Contract #: 04-0120F4Cty: SF/ALA Rte: 80 PM: 13.2/13.9File #: 69.28**WELDING INSPECTION REPORT****Resident Engineer:** Pursell, Gary**Address:** 333 Burma Road**City:** Oakland, CA 94607**Report No:** WIR-014770**Date Inspected:** 13-Jun-2010**Project Name:** SAS Superstructure**OSM Arrival Time:** 700**Prime Contractor:** American Bridge/Fluor Enterprises, a JV**OSM Departure Time:** 1900**Contractor:** Zhenhua Port Machinery Company, Ltd (ZPMC), Changxing Island **Location:** Shanghai, China

WELDING INSPECTION REPORT

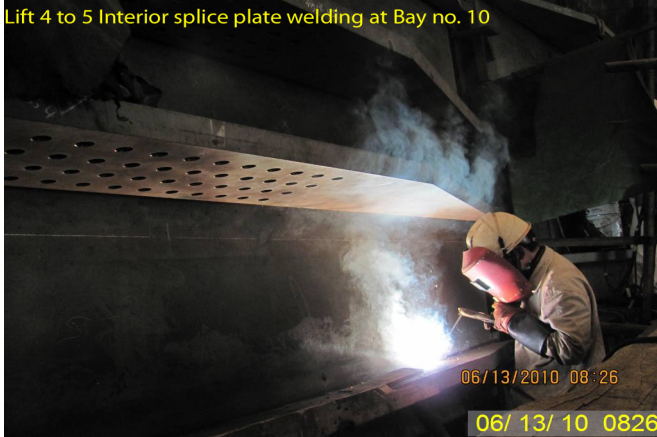
6.This QA inspector, Baskar Govindarajan, observed, ZPMC qualified welding personnel identified as 044511 perform SMAW welding on; Lift 4 to 5, interior splice plate and the weld joint is identified as NSD1-SPSA5-6-4A. ZPMC CWI Identified as Mr. Liu Yang. The welding parameters as measured using QC's calibrated instruments appeared to be in general compliance with WPS-B-T-3211-TC-U5B-1.

7.This QA inspector, Baskar Govindarajan, observed, ZPMC qualified welding personnel identified as 050289 perform SMAW welding on; Lift 4 to 5, interior splice plate and the weld joint is identified as NSD1-SPSA5-19-2B. ZPMC CWI Identified as Mr. Liu Yang. The welding parameters as measured using QC's calibrated instruments appeared to be in general compliance with WPS-B-T-3211-TC-U5B-1.

Lift 4 to 5 Interior splice plate welding at Bay no. 10

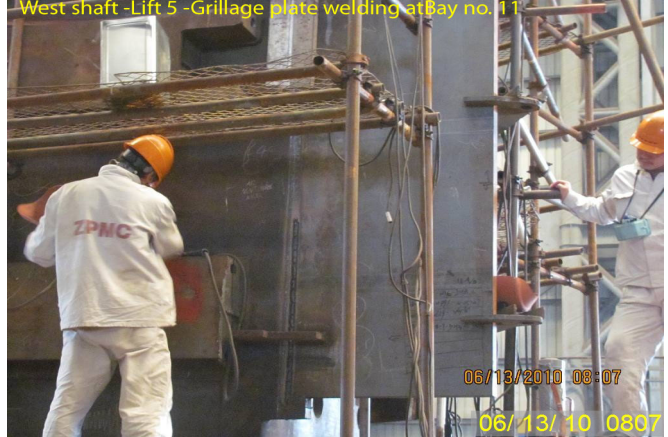
5.This QA inspector, Baskar Govindarajan, observed, ZPMC qualified welding personnel identified as 040619/040704 perform SMAW welding on; West Shaft, Lift 5 Grillage plate and the weld joint is identified as WSD1-TL5-4 B/F-34A, 34B. ZPMC CWI Identified as Mr. Xu Le Feng. The welding parameters as measured using QC's calibrated instruments appeared to be in general compliance with WPS-B-T-3213-B-U3B. (Photo attached)

West shaft -Lift 5 -Grillage plate welding at Bay no. 11
